14 THE SOURCE HOTEL, LLC,

**SHADY BIRD LENDING LLC'S REPLY
TO OPPOSITION TO MOTION OF
SHADY BIRD LENDING, LLC FOR
ORDER EXCUSING STATE COURT
RECEIVER FROM TURNOVER OF
ASSETS PURSUANT TO 11 U.S.C. §
543; DECLARATIONS OF BELLANN R.
RAILE, BRENT LITTLE, AND ANDREW
TROST IN SUPPORT THEREOF**

DECLARATION OF ANDREW TROST

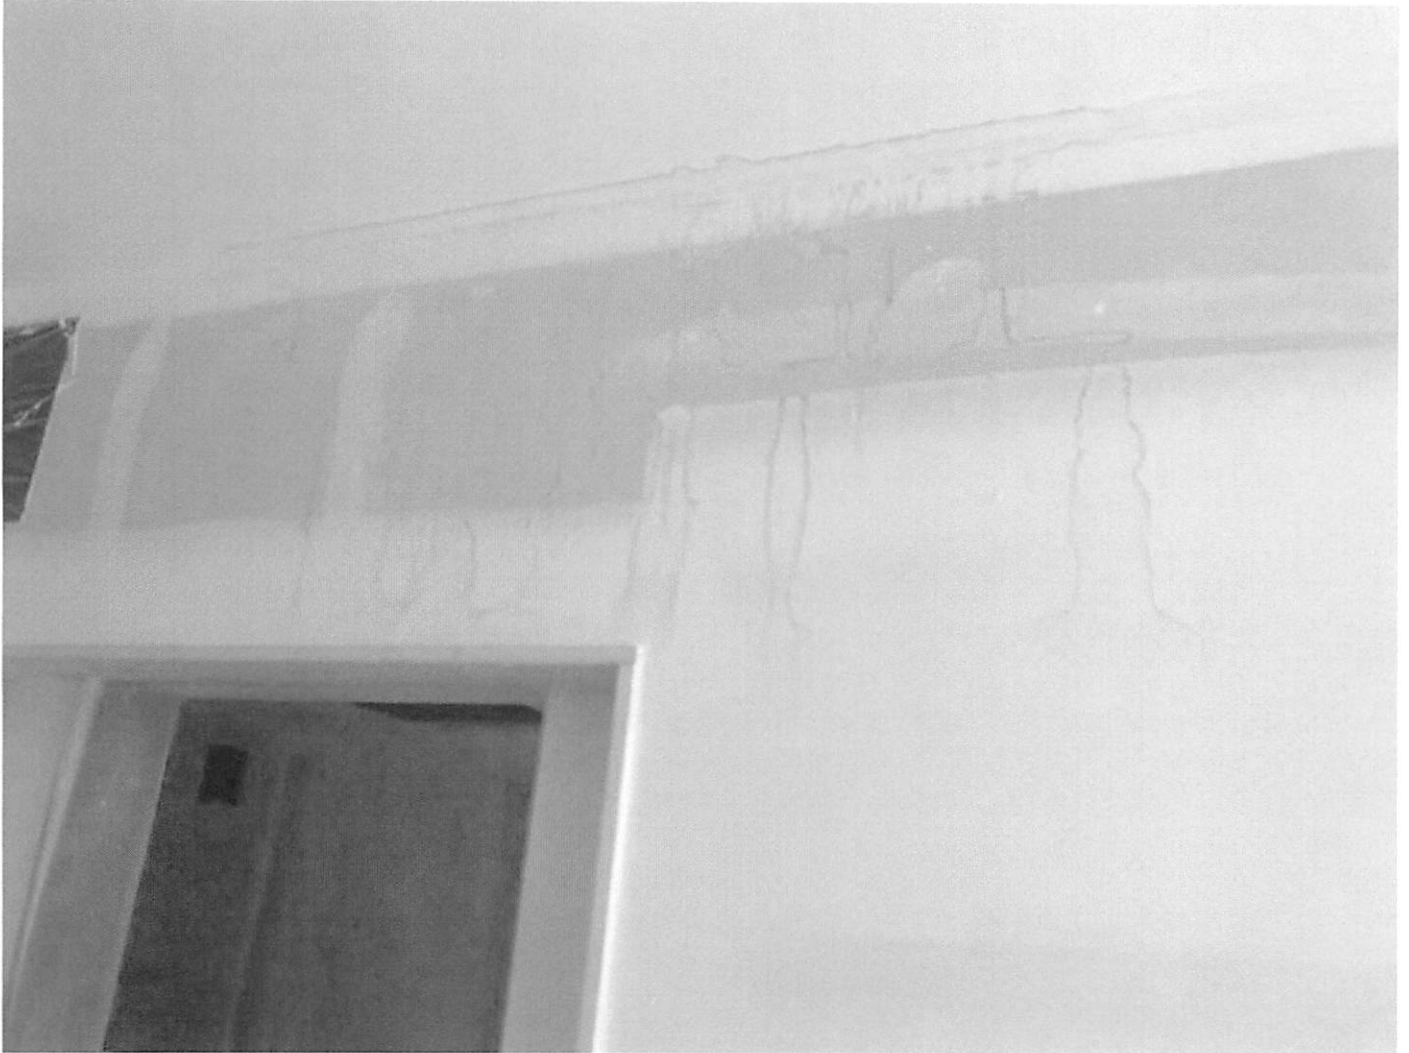
Room 738:

19 16. In addition to falsely creating the impression that I created or caused
20 problems to exist, the Cervantes Declaration incorrectly states that "[n]either the Receiver
21 nor I are aware of any leaks." Actually, I am aware of some stained ceiling tiles in the
22 rooms on the 7th floor. True and correct copies of photographs I commissioned
23 evidencing potential leaks are attached hereto as Exhibit "D" and incorporated herein by
24 reference.

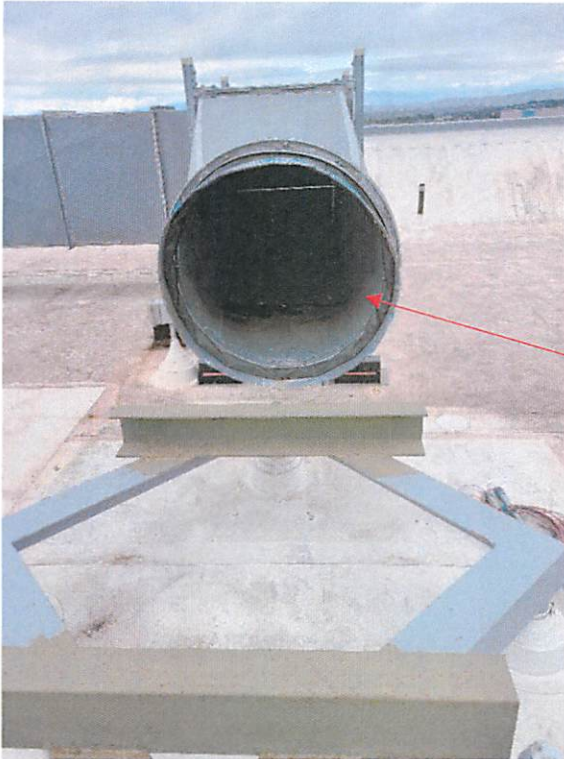
Picture 1 – Unprotected vent.

- a. The application of plastic is not universal and numerous opening did not contain any covering. See Picture 1 below.
 - b. Several roof vents are missing, which will allow water and pests to enter the building. See Picture 2 below.

- 19 • The application of plastic is not universal and numerous opening did
20 not contain any covering (see Picture 1 in the Second Report);
- 21 • Several roof vents are missing, which will allow water and pests to
22 enter the building (see Picture 2 in the Second Report);
- 23 • In the Cervantes Declaration, Mr. Cervantes seems to indicate the
24 placement of plastic film is acceptable, however, polyethylene plastic is highly susceptible
25 to degradation from exposure to the sun, through UV radiation. As a result, the correct
26 permanent solution is a sheet metal duct cap (see Picture 3 in the Second Report); and
- 27 • A review of Google Earth pictures seem to indicate the roof has had
28 a long-term temporary solution to water intrusion (see Picture 4 in the Second Report).

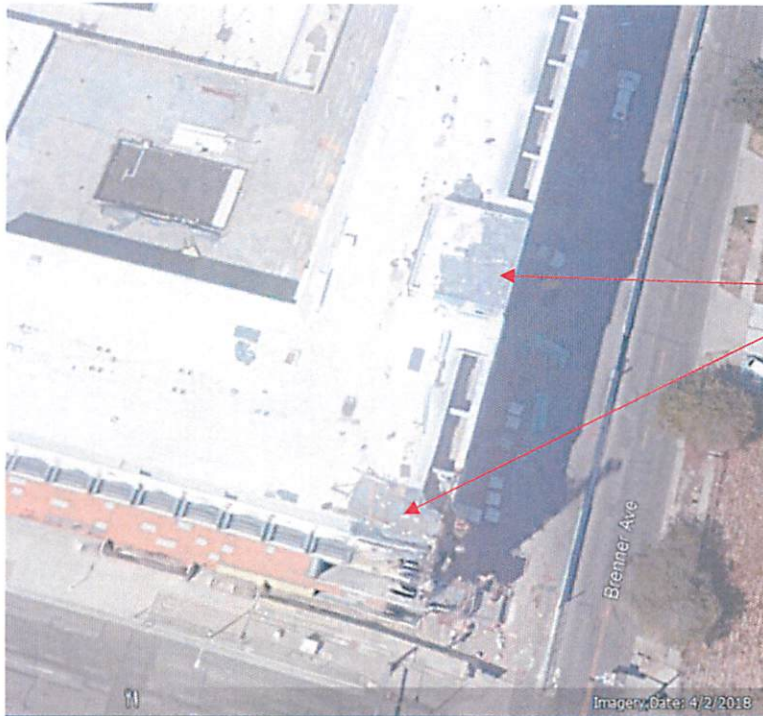
Picture 4 – Roof in April 2018 with temp coverings.

- d. A review of Google Earth pictures seem to indicate the roof has had a long-term temporary solution to water intrusion. See Picture 4 below:

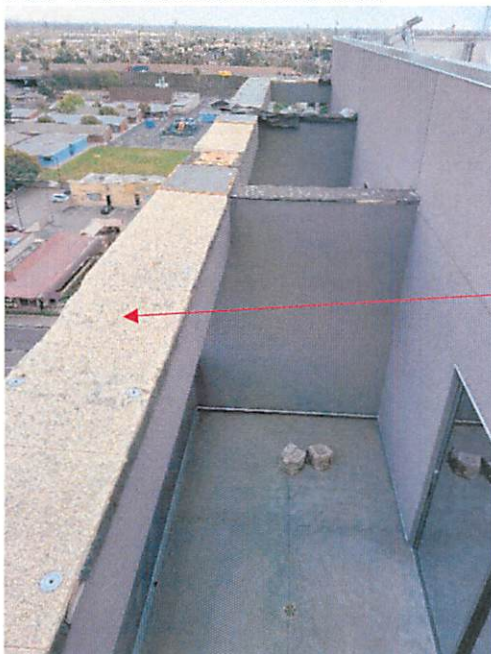
Picture 5 – Exposed roof substrate.

2. **Incomplete Construction Assemblies Water Intrusion** – The term construction assembly is an industry recognized term that refers to all the components of given portion of building, which when assembled together serve a specific purpose. In the case of the roof, the assembly is comprised of all components designed to protect the structure from water intrusion. As can be seen from Pictures 5 and 6, a roof failure existed and was in the midst of being repaired when construction ceased. Picture 5 shows the completed repair with flashing covering, while Picture 4 shows the roof torn off and exposed wood. Picture 7 is a close up of the incomplete repair. Furthermore, it was evident the Debtor had tried to mitigate water intrusion by use of sand bags and plastic that were located near or on the roof at this area.

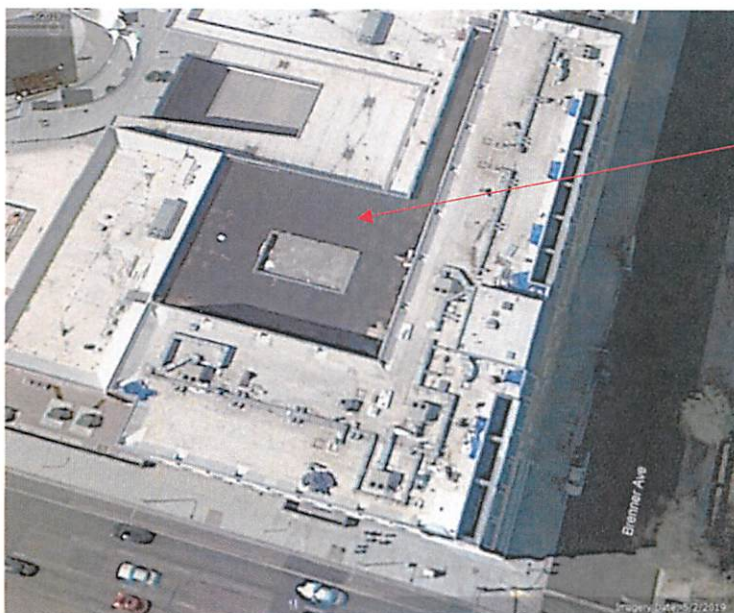
Picture 8 – Exposed pool deck
5/2019.

4. **Pool Deck** – It is clear the pool deck water proofing has been exposed to years of excess exposure. Picture 8 below is a screen shot from Google Earth in May of 2019. In this picture, the pool deck is completely uncovered. Moreover, the damage from excessive sun and UV exposure was readily noticeable by the amount of friable roof material readily sloughing off. This can be seen in Picture 9 below. I am also concerned by Mr. Cervantes' statement that his construction crew applied sealant over the area. Typically, a contractor engaged in roofing or waterproofing would have either a C-39 roofing or C-

33 painting license. Moreover, most manufactures of waterproofing systems require trained and licensed installers to performing maintenance and installation of their system or the warranty may be voided.

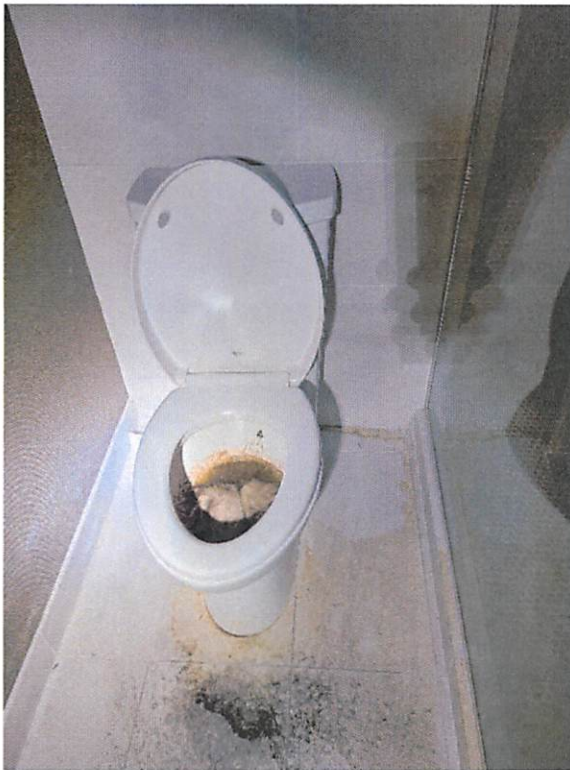
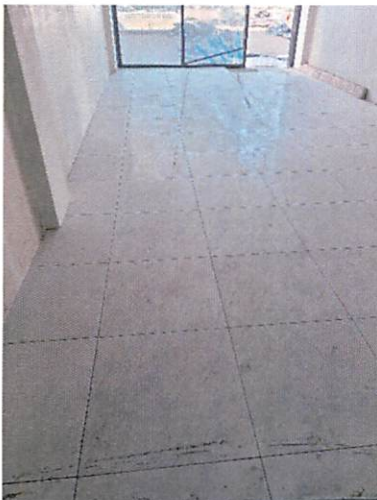
5. **Pool Water & Trash** – From our observations, the water and trash had been in the pool for some period of time. A review of both Weather.com and Weather Underground did not reveal any periods of rain between 2/17 (onset of Receivership) and 3/3 (first inspection). Several inches of rain occurred prior to the Receivership and it appears as though this water may not have been removed.
6. **Completed Business Finish Waste** – The construction phasing was performed in such a manner that completed finishes (carpet, floor tile, showers, plumbing fixtures, wall coverings and cabinetry) are subject to construction traffic and exposure. Very little protective measures have been instituted to guard against damage and destruction. Both the tile and carpet flooring are uncovered and being subjected to unusual damage. See pictures below:
